SUBJECT: Operational Report - Lessons Learned, Headquarters, 577th
Engineer Battalion (Const), Period Ending 31 January 1968 (U)

DEPARTMENT OF THE ARMY
HEADQUARTERS, 577TH ENGINEER BATTALION (CONSTRUCTION)
APO US Forces 96316

SUBJECT: Operational Report - Lessons Learned (RCS CSFOR-65), for
Quarterly Period Ending 31 January 1968

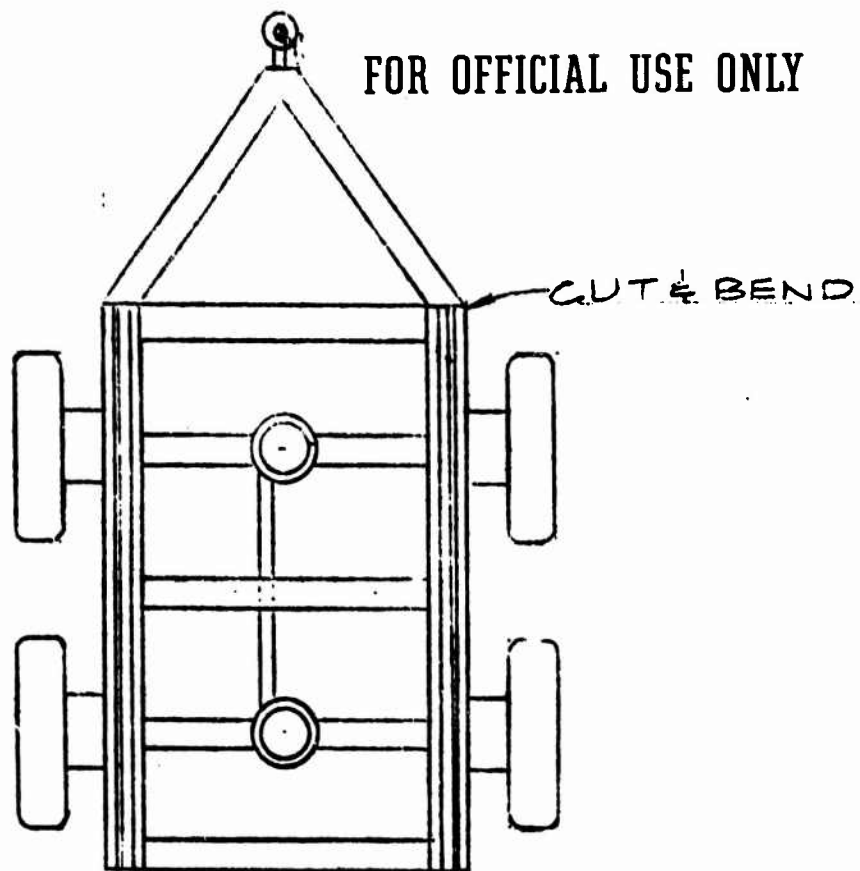
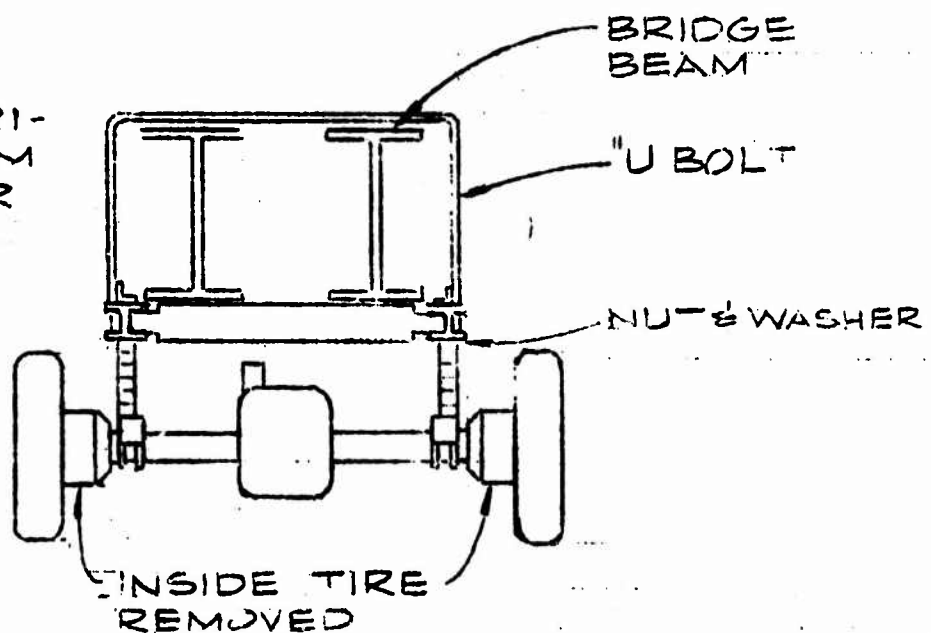
DOLLY TRAILER

Discussion: For bridge construction, long heavy beams and girders must often be transported over narrow winding roads where operation of 25 ton tractor-trailers is difficult and hazardous due to the overhang of the beams. A dolly-trailer was constructed from a salvaged M61 water distributor chassis and the goose-neck of a 25-T trailer (see sketch, Incl 3). The tractor chassis was cut off behind the cab, and the rear section was modified by eliminating the inside duals, providing a wider wheel base. Angle iron was used for bracing to prevent sliding of the beams. Four-foot long U-bolts were fabricated to secure the beams and a pintle hook was attached to pull the dolly when not hauling beams. The gooseneck of a 25-T trailer was modified by using angle iron as bracing to prevent sliding of the beams and again four-foot long U-bolts were used to secure the beams (see sketch, Incl 3).

Observation: Transportation of long length beams can be made easier through the use of a dolly-trailer.

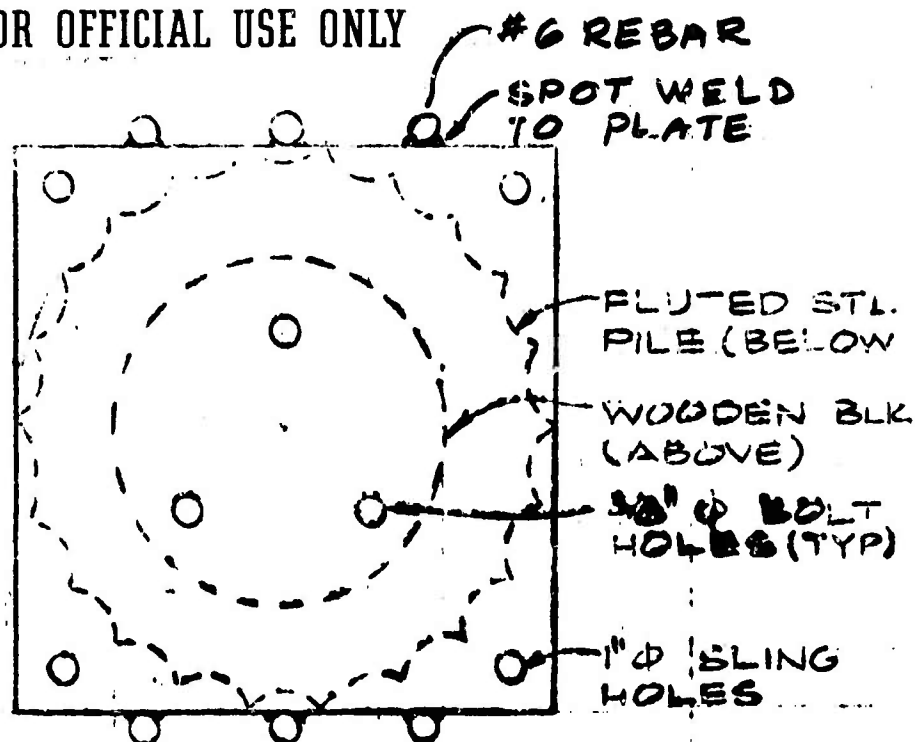
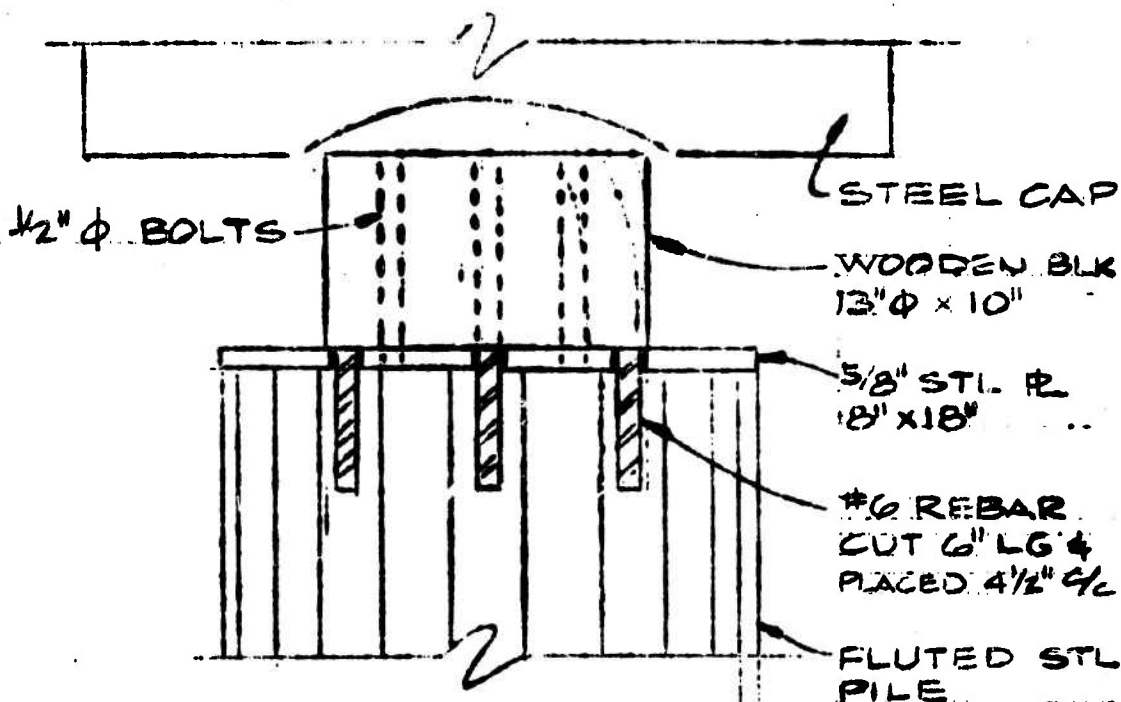
FLUTED STL PILE CAP ADAPTOR

Discussion: To drive an 18-inch diameter fluted steel pile, a cap must be prefabricated since the pile cap normally found with the 3,000-pound hammer is too small. A 5/8 inch thick steel plate was cut 18 inches square, with three 6-inch pieces of #6 rebar welded at 4 1/2 inch intervals on both sides of the plate. (See Incl 4).

Observation: A pile cap adaptor can be fabricated from locally available materials which will provide adequate control for driving fluted steel piles.

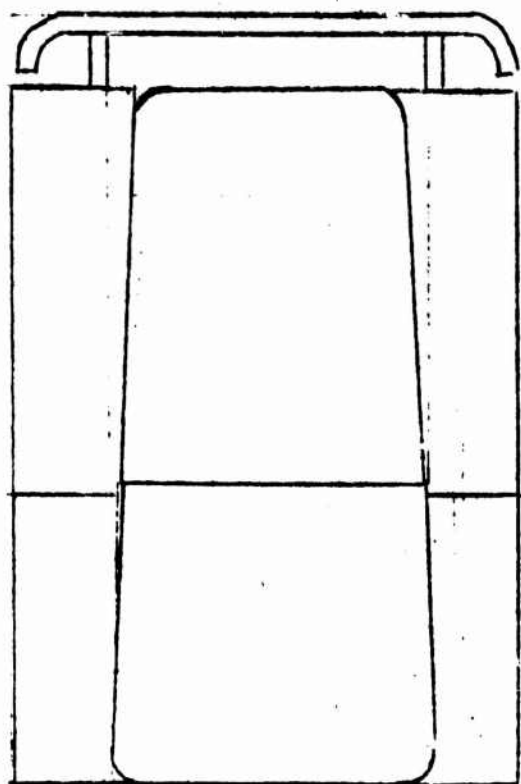
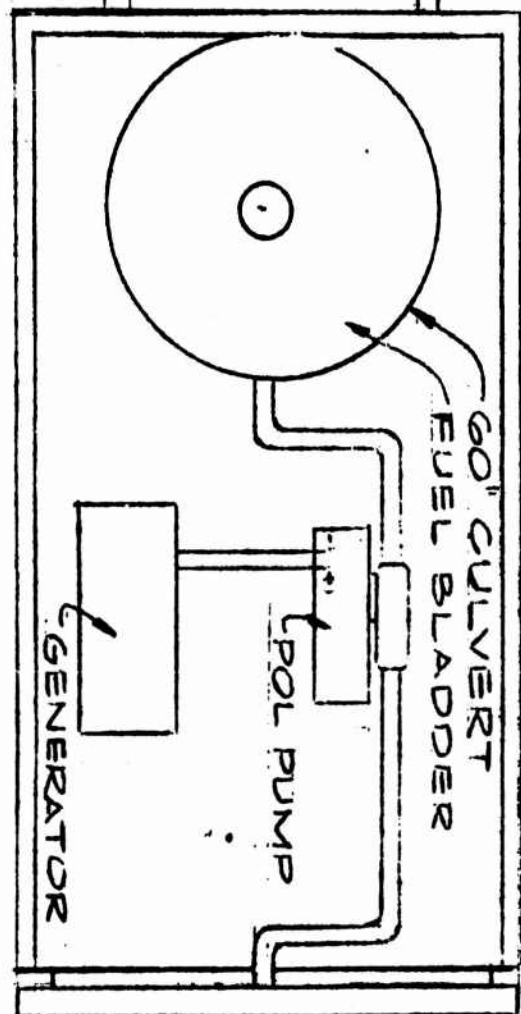
EXPEDIENT ASPHALT DISTRIBUTOR

Discussion: Asphalt distributors were in short supply and in great demand. The nonavailability of a distributor prompted the improvisation of an expedient distributor. The distributor was constructed using a 2 1/2 ton truck, a

section of 60" culvert, a generator, an electric pump, a POL bladder, and a pipe. When assembled, the unit has the capability to distribute cutback or emulsified asphalt for use as a dust palliative. (See Incl 5).

Observation: From materials and equipment normally available, an expedient asphalt distributor can be constructed and used for application of asphalt cutback.

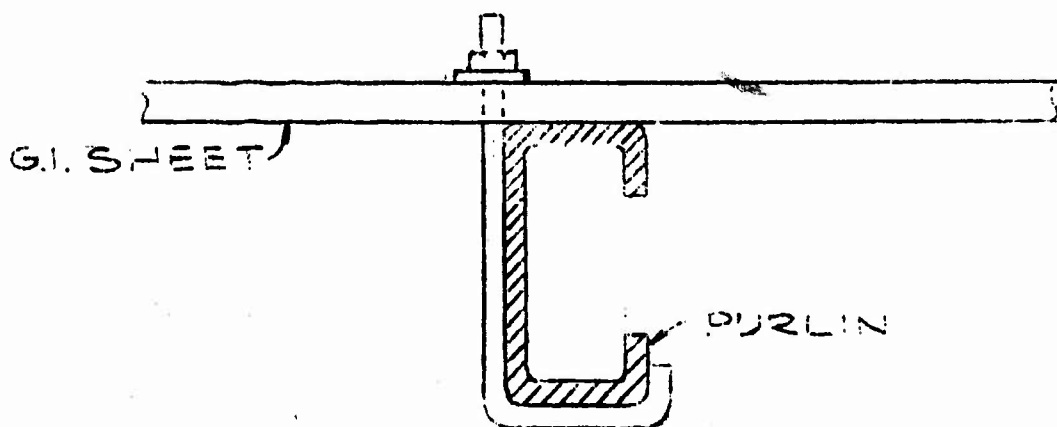
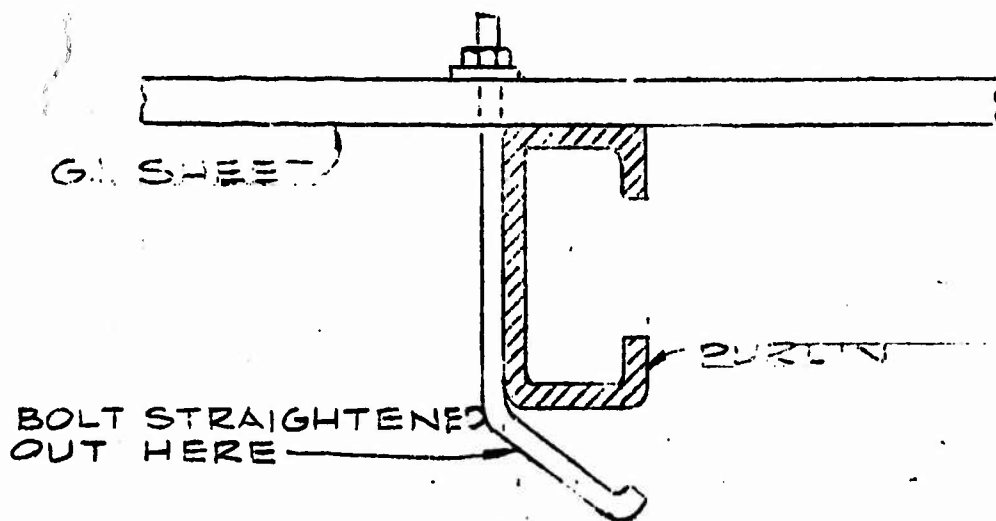
FOR OFFICIAL USE ONLY
ROOFING FASTENERS FOR HANGAR

Discussion: During Typhoon Freida the roof of the Nichimen 75' x 202' steel maintenance hangar at the Phu Hiep Army Airfield was subjected to a high dynamic wind loading and was blown off. The roof was constructed of heavy gage corrugated metal sheeting fastened to the roof purlins by use of 3/16-inch diameter J-bolts. It was observed that the bolts failed by bending (straightening out) and became disengaged from the purlins. No additional bolts were on hand to replace the damaged ones and experiments were conducted using a self-tapping screw driven thru the sheet metal into the purlin. This screw provided adequate holding power and had the advantage of easy and rapid installation. (See Incl 6).

Observation: The large J-bolts supplied with the Nichimen 75' x 202' maintenance hangar are inadequate. A self-tapping screw which is adequate and easier to install can be substituted.

A. J-BOLT INSTALLED

B. FAILURE OF J-BOLT

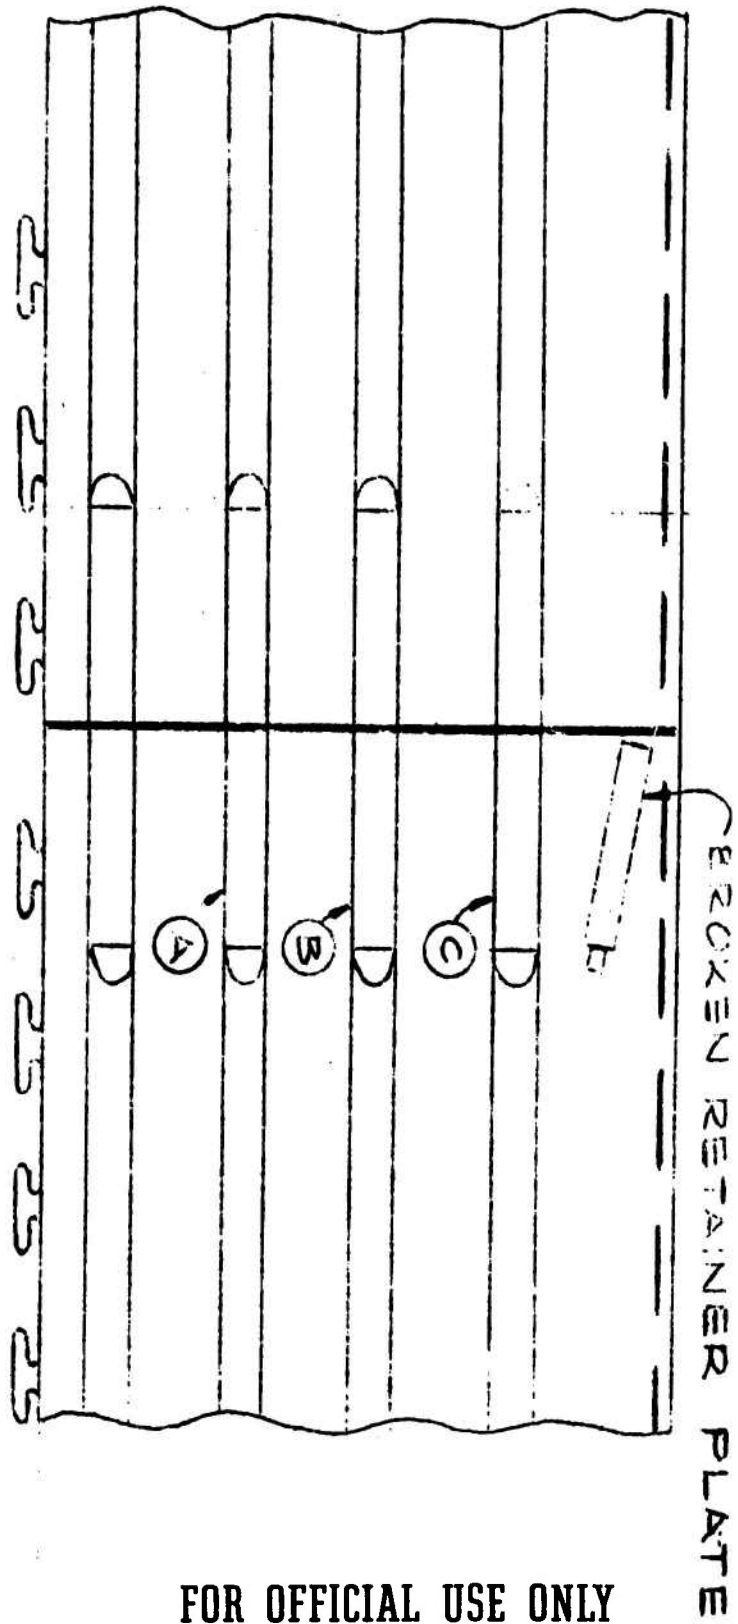
SURFACE FAILURE
OF
PHU HIEP ARMY AIRFIELD

Discussion: Phu Hiep Army Airfield is a 3,500-foot runway constructed of M8A1 mat over a one inch sand blanket over 10" of sand-cement base. A recent inspection of the mat on the airfield revealed a large number of weld failures. This weld is a factory weld in the mat which connects the retainer plate over the locking pins to the mat. When this plate is gone the mat can come apart, and loose pins and retainer plates on the runway create a safety hazard to aircraft. (See Incl 7). Investigation revealed the following:

(1) Over 800 sorties of C130 aircraft and 3,000 of OV-1 Mohawk aircraft have landed on the surface.

(2) The failures took place at the touchdown points on both ends of the field and in the propeller reversal zone at about midlength of the runway.

(3) The runway is adjacent to the South China Sea, thus exposing it to salt water.

Observation: The M8A1 mat at Phu Hiep Army Airfield has exceeded its design life of 200 C-130 sorties. The airfield will be in operation for an undetermined period of time and will require ever-increasing maintenance.

c. Section 2, Part I 2i: The M8A1 matting failure reported at Phu Hiep is strikingly similar to the M8A1 matting failure witnessed by the 14th Engr Bn at Bao Loc Airfield.

a. Reference Section II, Part 1, Item 2i; this Headquarters has initiated a study to determine the extent and nature of the failures of MSA1 matting. While the results of the study are not final, indications are that these failures are limited to points of maximum stress and that they can be readily detected and repaired through normal maintenance procedures.

1 WELD CRACKED AT CONNECTOR (A)
2. CONNECTOR RETAINER PLATE (B)
RAISED & FAILED, EXPOSING END
CONNECTORS (C)

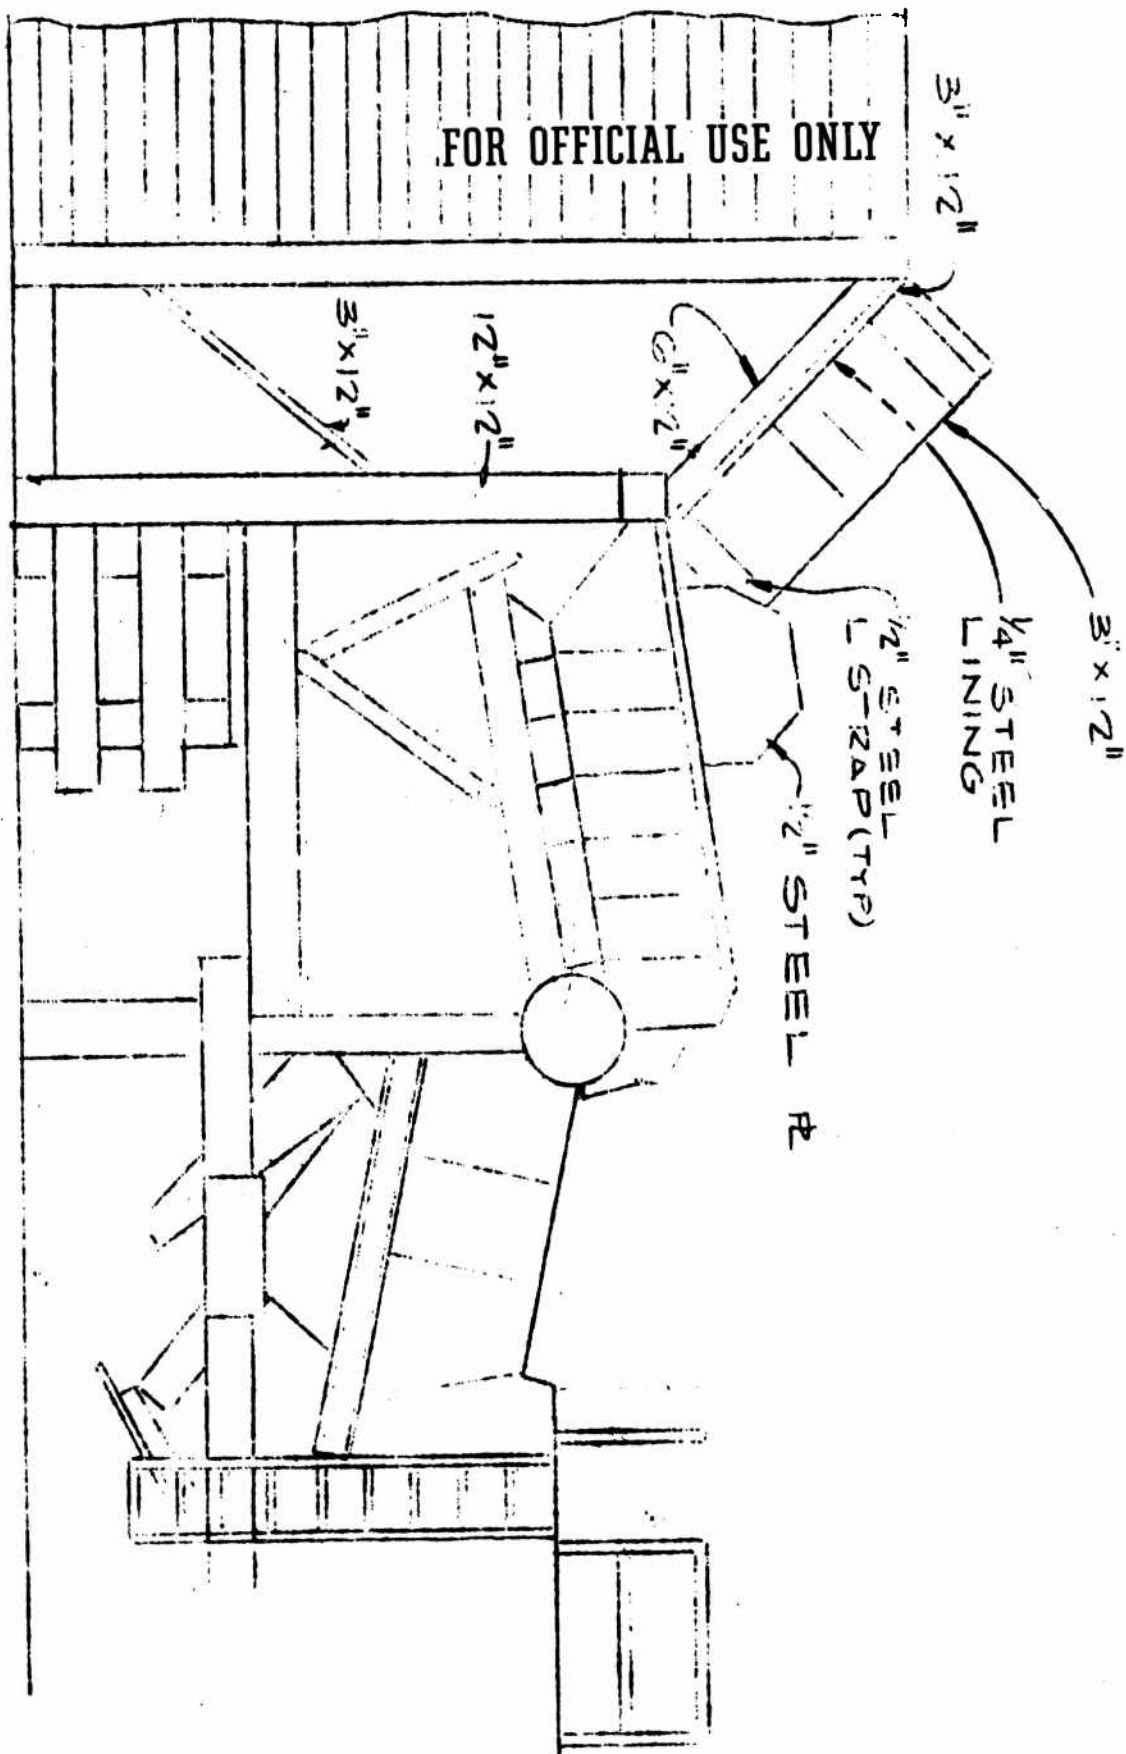
DUMPING CHUTE FOR 75TPH PRIMARY CRUSHER

Discussion: When loading a 75TPH Eagle primary crusher by a 5 ton dump truck, considerable wear resulted on the drive system for the hopper and
